Manhole Inspection Summary

Manhole # S25I__019MH

Location Address: **1100 W. Pratt**

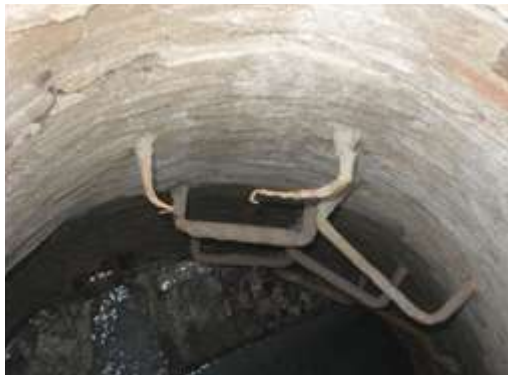
Defect 1

Count: **7** Missing: **2** ☒ **Corroded**

missing and corroded steps

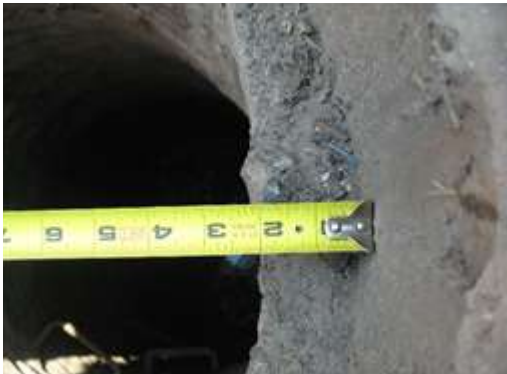
Defect 6

Offset: **2** (in.)

2" offset

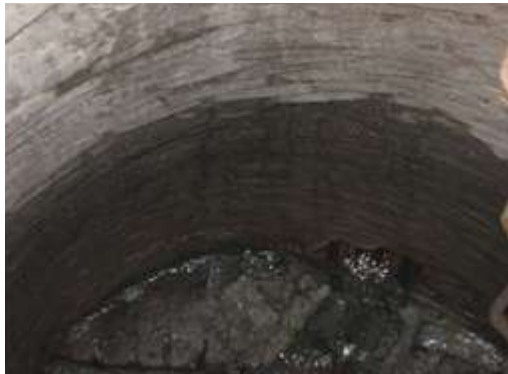
Defect 4

☒ **Evidence Of Surcharge** Depth: **3** (ft.) ☐ Active Surcharge Present

evidence of surcharge with debris on bench

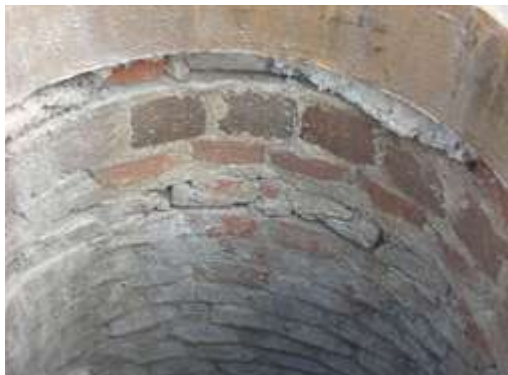
Defect 2

Condition: ☐ Sound ☐ Cracked ☐ Root Intrusion ☒ **Loose Brick** ☐ Deteriorated

corbel loose bricks

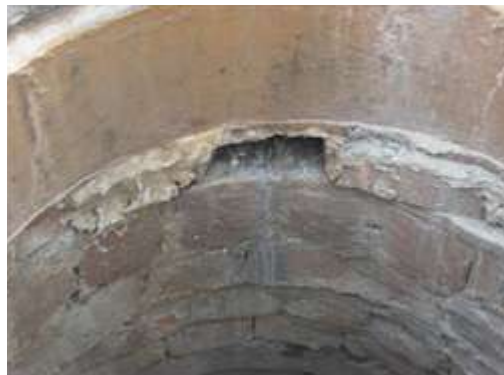
Defect 5

Condition: ☐ Sound ☐ Cracked ☐ Root Intrusion ☒ **Loose Brick** ☒ **Deteriorated**

Infiltration: ☐ None ☐ Joint ☐ Cracks ☐ Mortar ☐ Roots ☒ **Wall**

deteriorated & loose/missing bricks at chimney, infiltration marks at wall

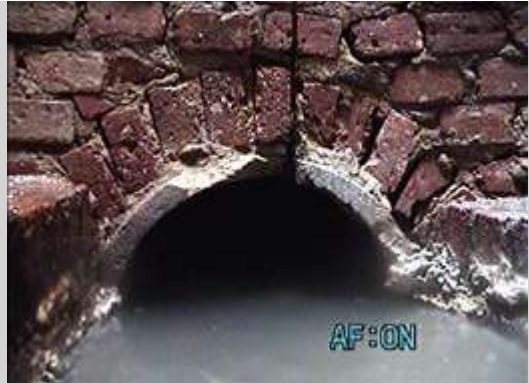
12 O'Clock Outflow

cracked joint

Infiltration: **None** Pipe Seal Cond: **Broken**
